Portage Creek Sediment Remediation Project Kalamazoo, Michigan

Post-Sediment Removal Structure Feature Assessment Removal Areas SA5-Axtell, SA5-D and SA5-C

F&V Project Number: 809930
October, 2012

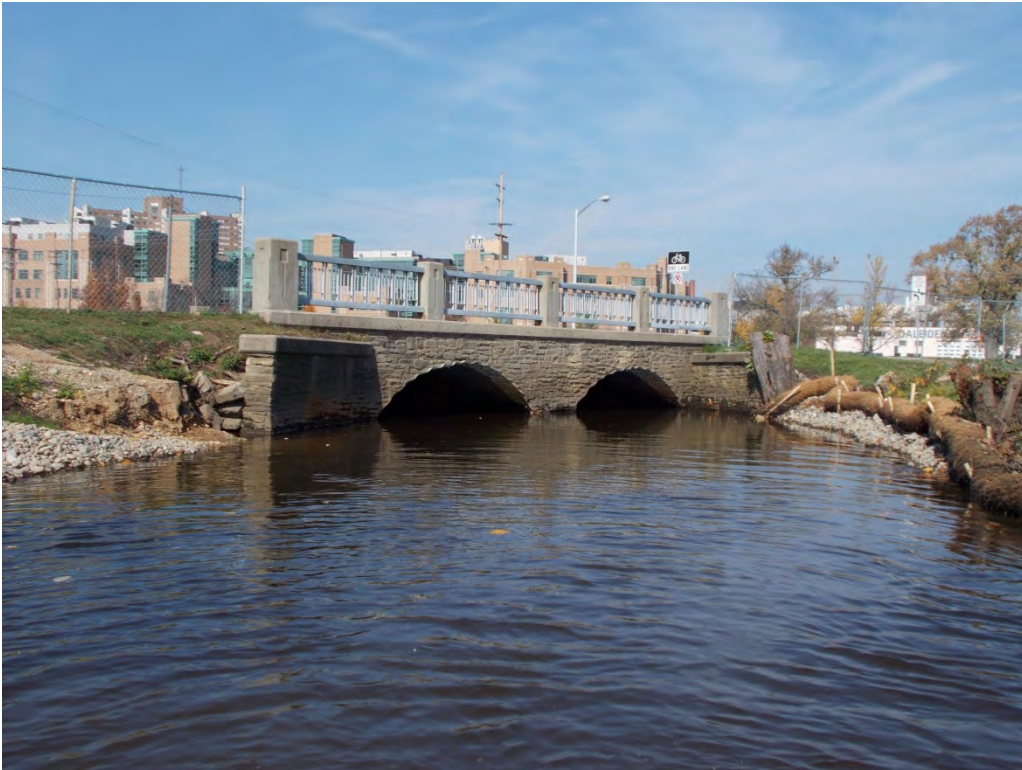
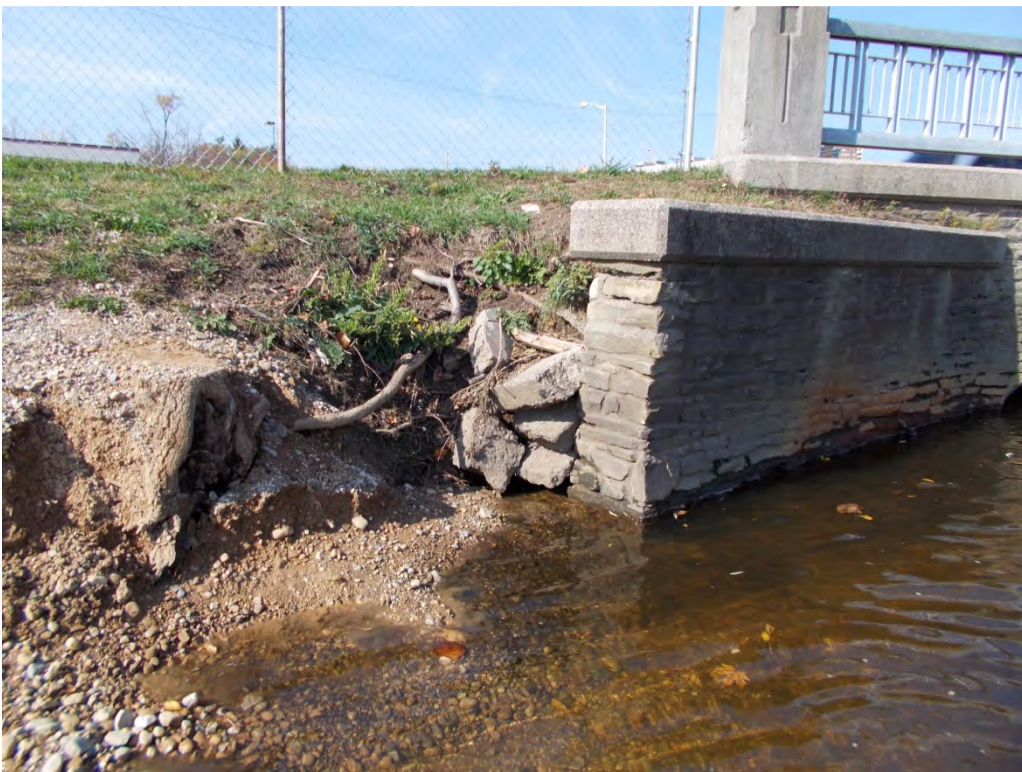
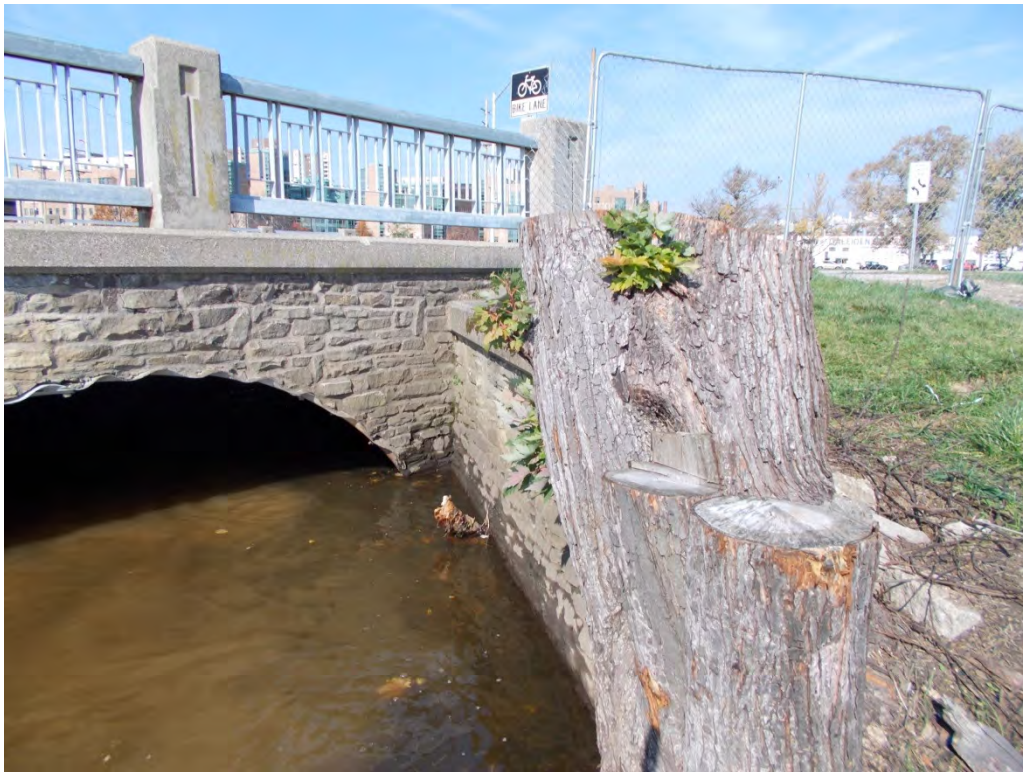
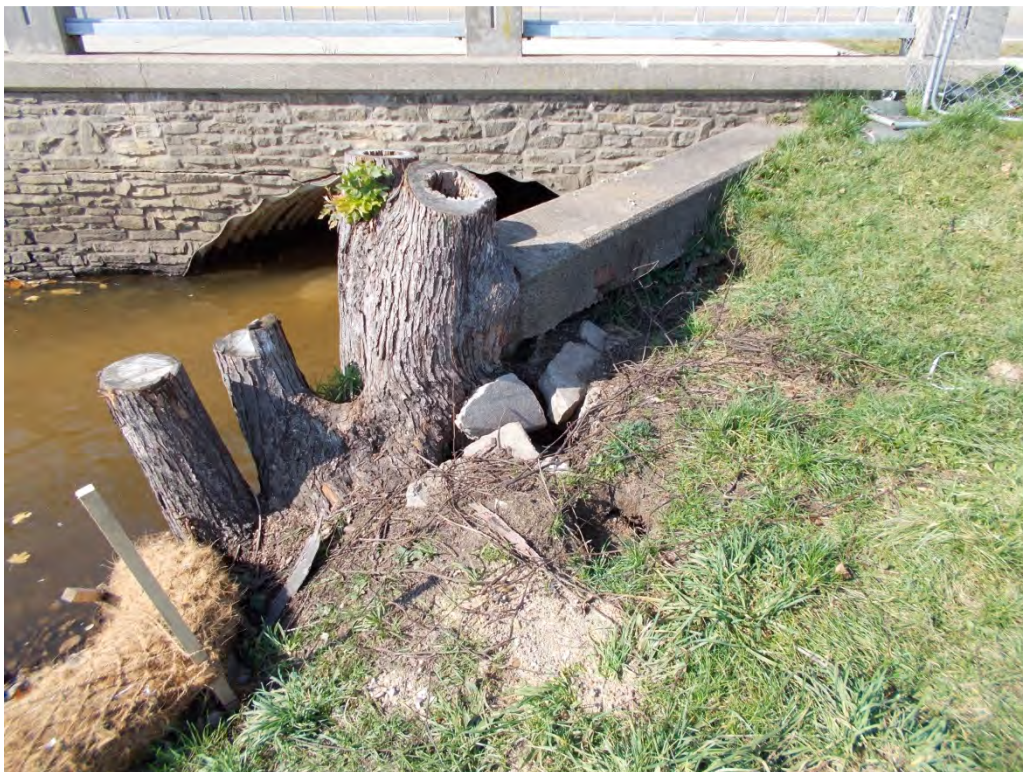
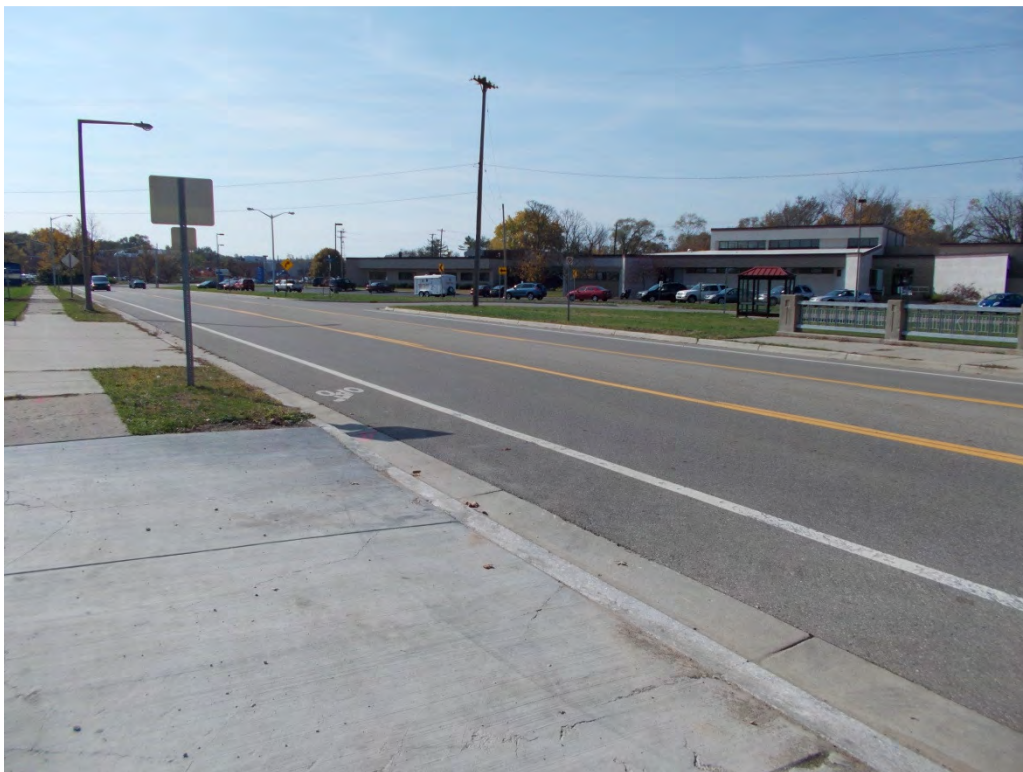
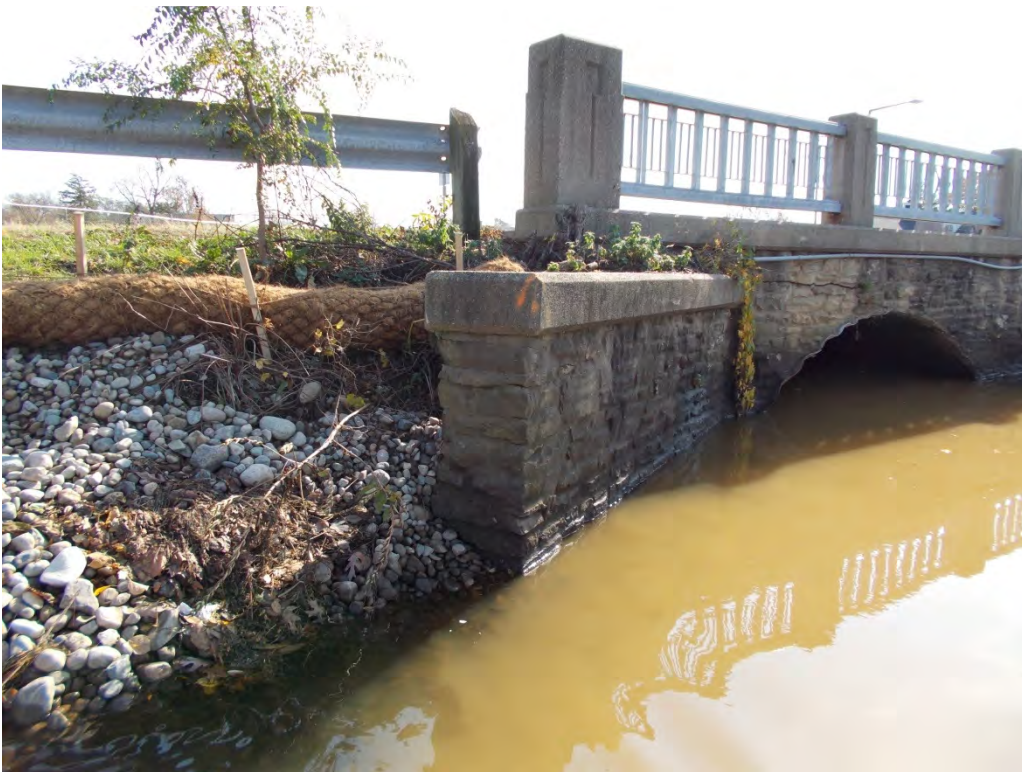
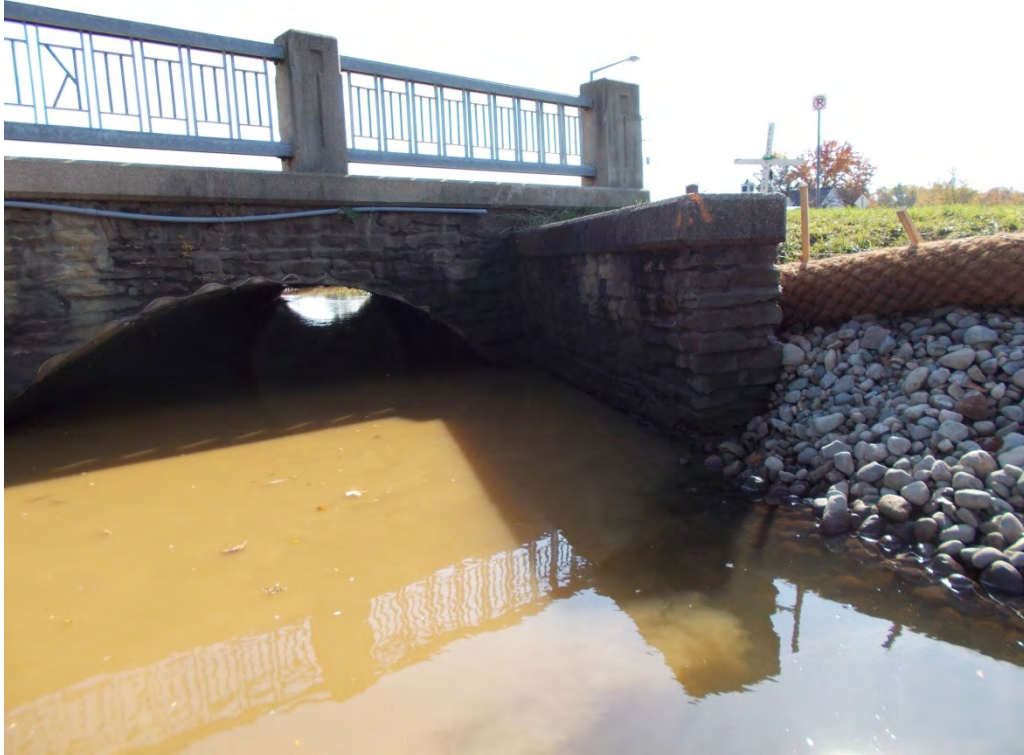
Designation: SA5-D-S13 / SA5-C-S01

- Cracking in the headwalls appears to be unchanged.
- Cracked sidewalk in the southeast and southwest appears to be marked for replacement, as well as a curb cut in the northeast.
- Restoration is required in the southeast, southwest and northeast quadrants.
- The structure itself does not appear to have been impacted during sediment removal.

Elevation view of the structure from the upstream channel

View of the southwest wingwall

View of the southeast wingwall

View of the structure from the southeast approach area

View of the northeast wingwall

View of the northwest wingwall

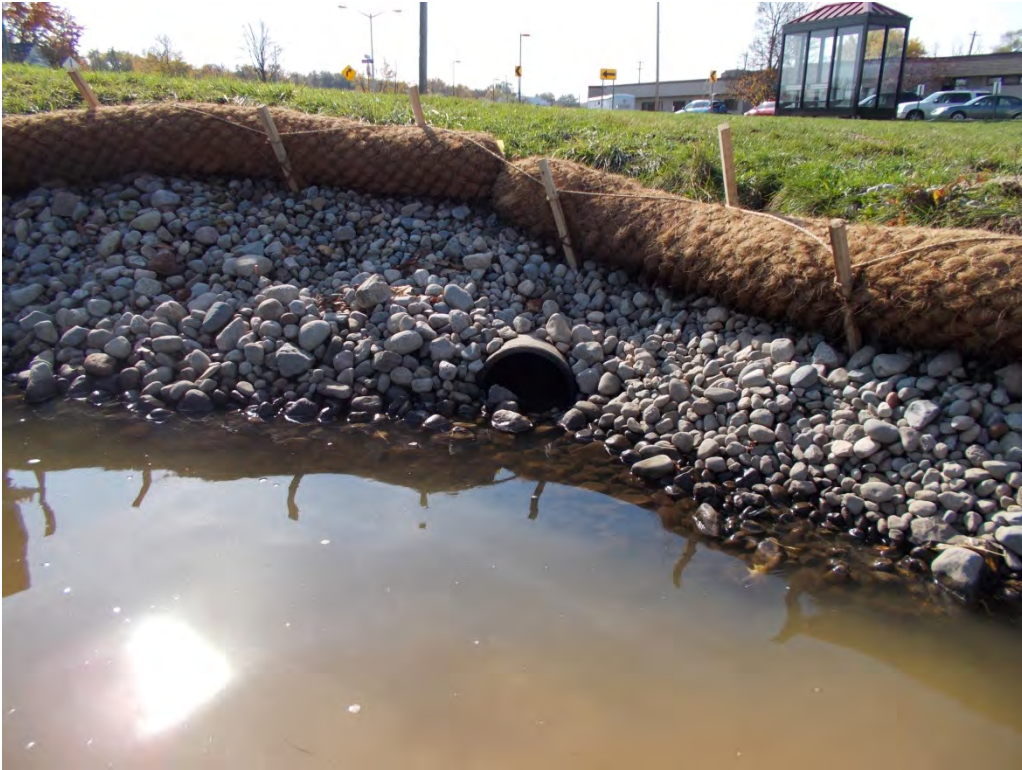
Designation: SA5-C-S02

- Failed end sections have been removed. The remaining outlet does not appear to have been impacted during sediment removal.

View of structure from the channel

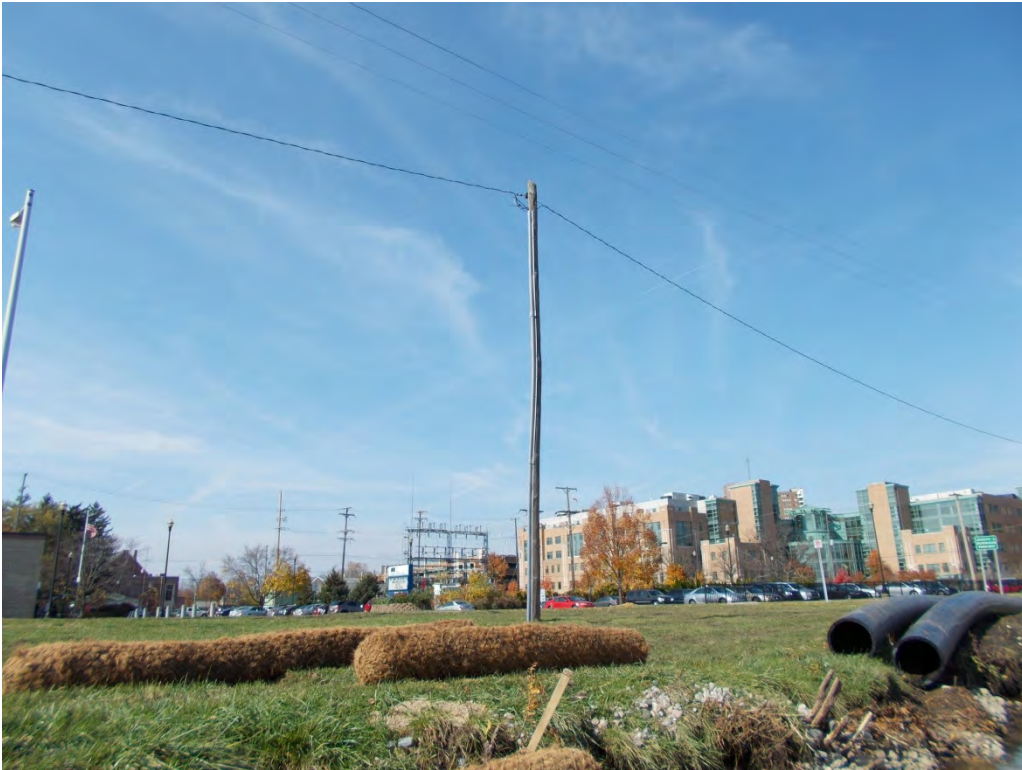
Designation: SA5-C-S03

- The structure does not appear to have been impacted during sediment removal.

View of pole from channel

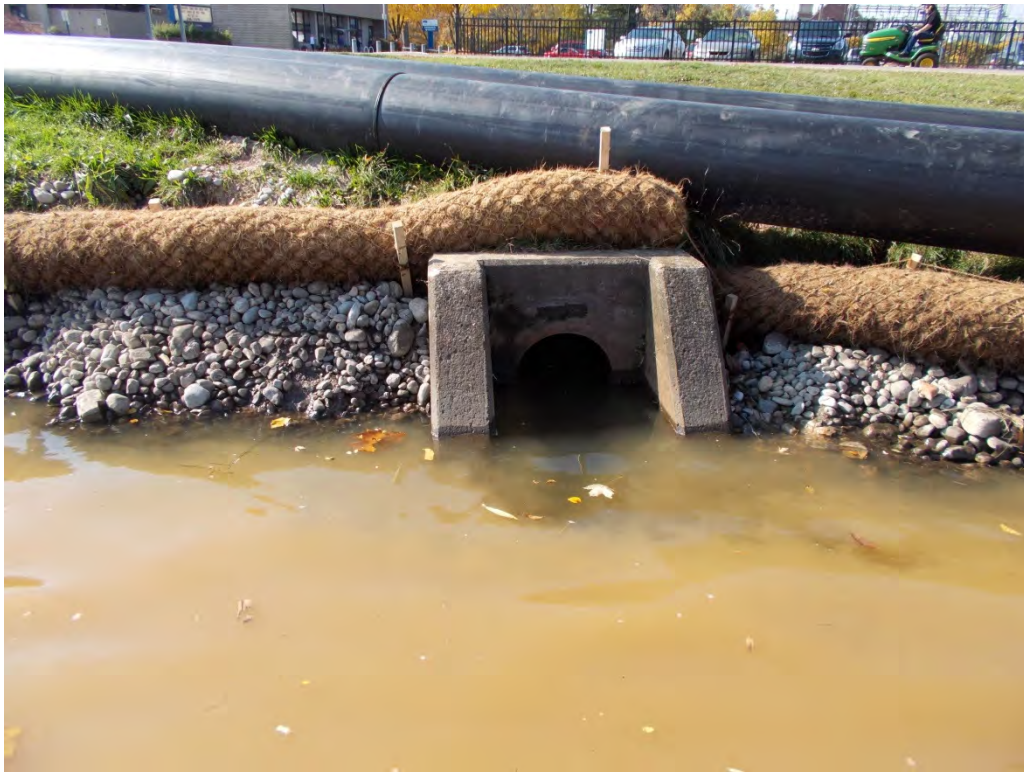
- The structure does not appear to have been impacted during sediment removal.

View of structure from the channel

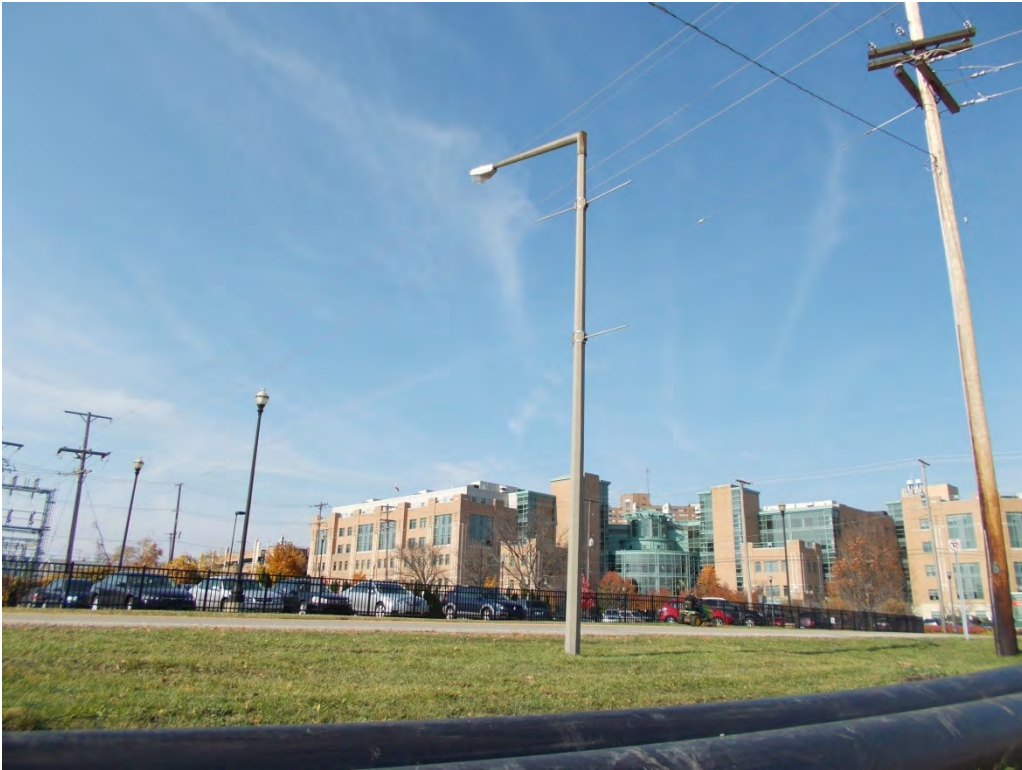
Designation: SA5-C-S06

- The structure does not appear to have been impacted during sediment removal.

View of the pole from the channel

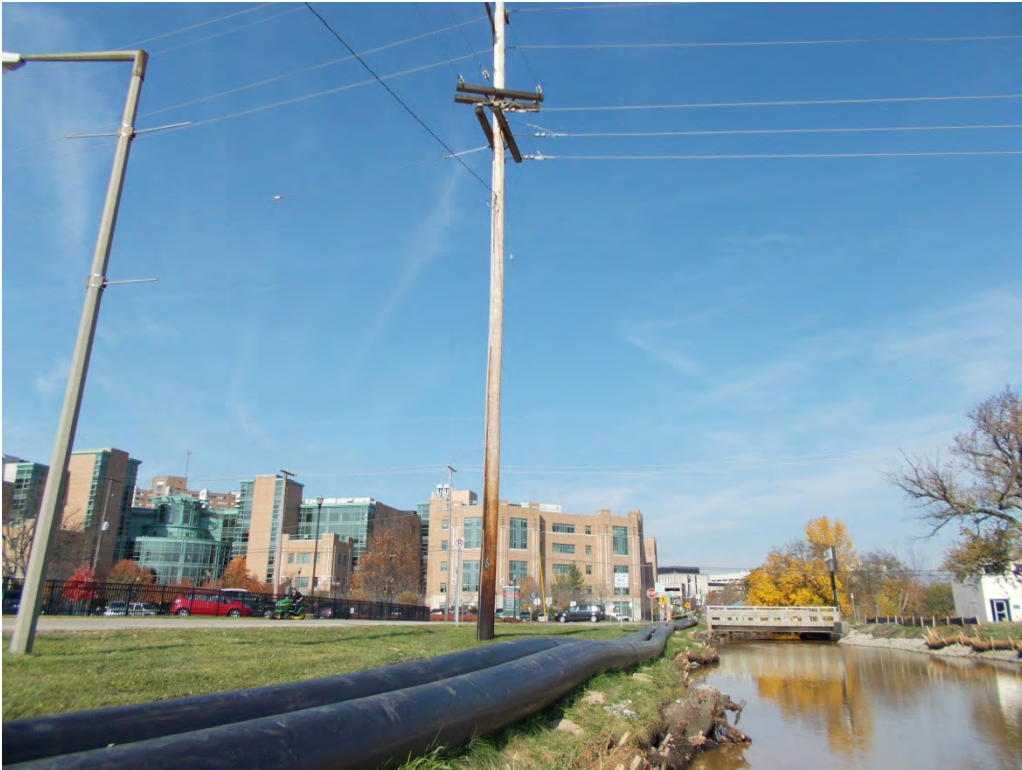
Designation: SA5-C-S07

- The structure does not appear to have been impacted during sediment removal.

View of the pole and guy from the channel

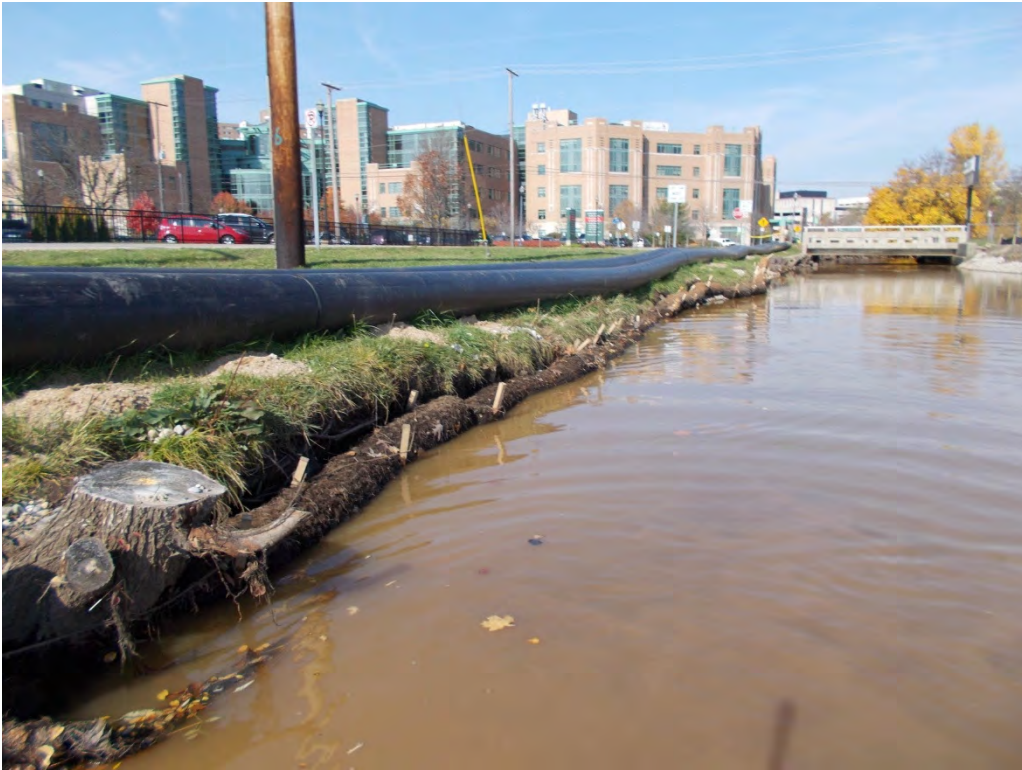
Designation: SA5-C-S08

- The structure was removed in conjunction with sediment removal operations.

Bank restoration in the previous area of the structure

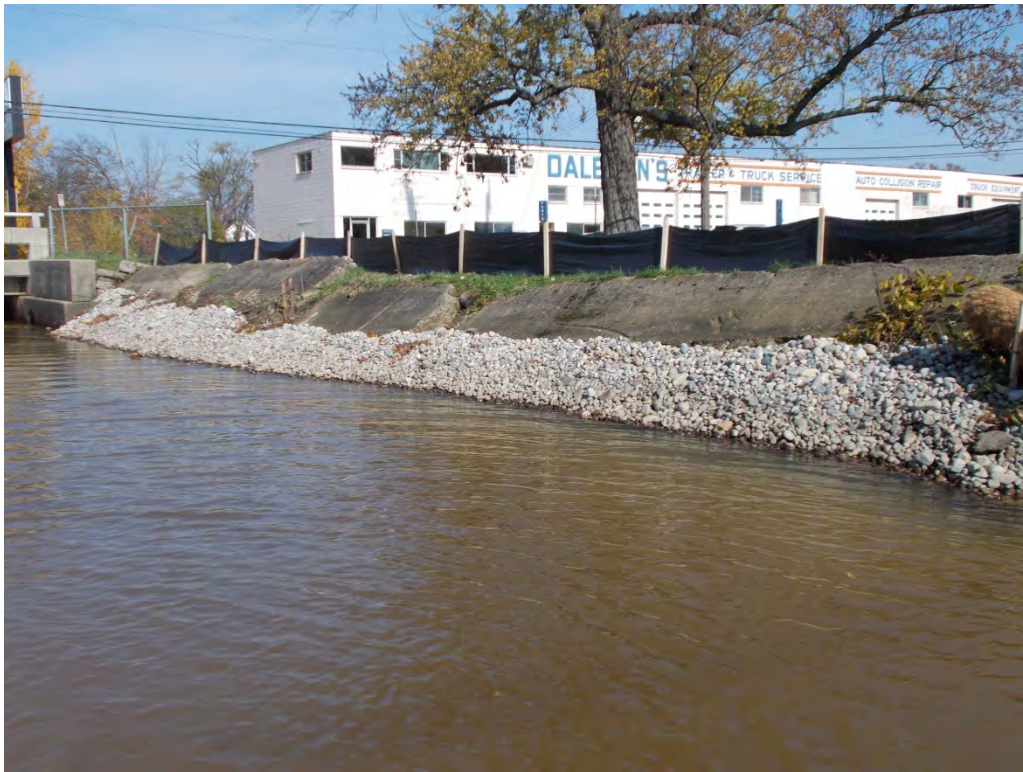
Designation: SA5-C-S09

- The structure does not appear to have been impacted during sediment removal.
- The bank has been restored around the structure.

View of the structure from the channel

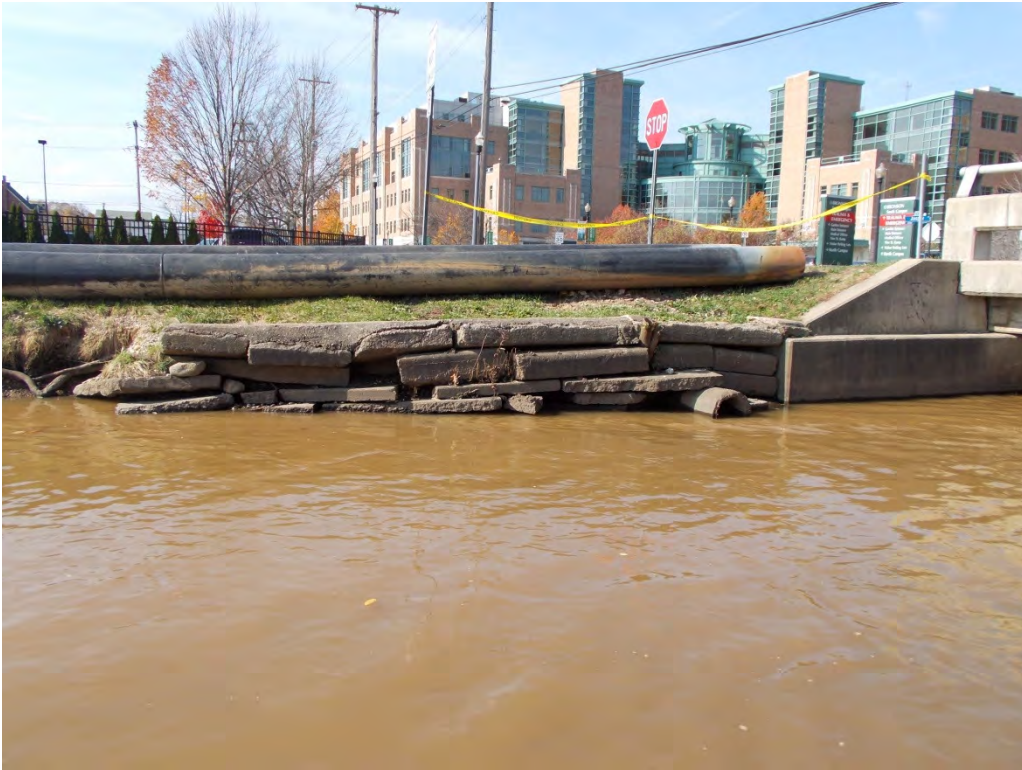
- The structure does not appear to have been impacted during sediment removal.

View of the structure from the channel

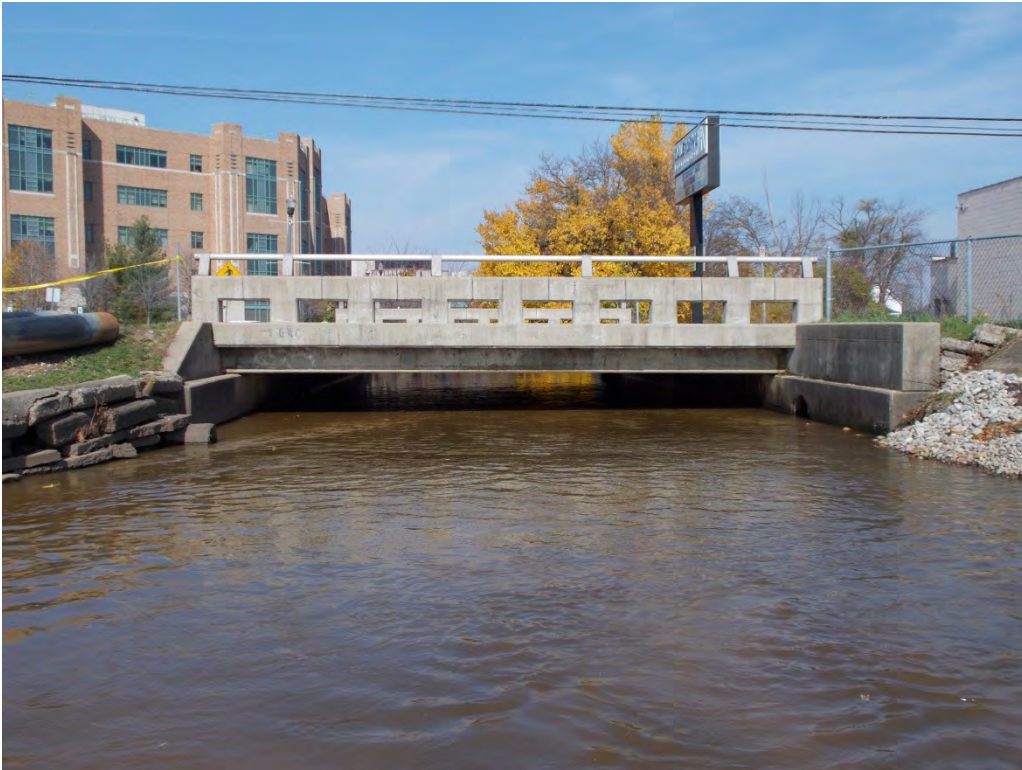
- The structure does not appear to have been impacted during sediment removal.

Elevation view of the structure from the upstream channel

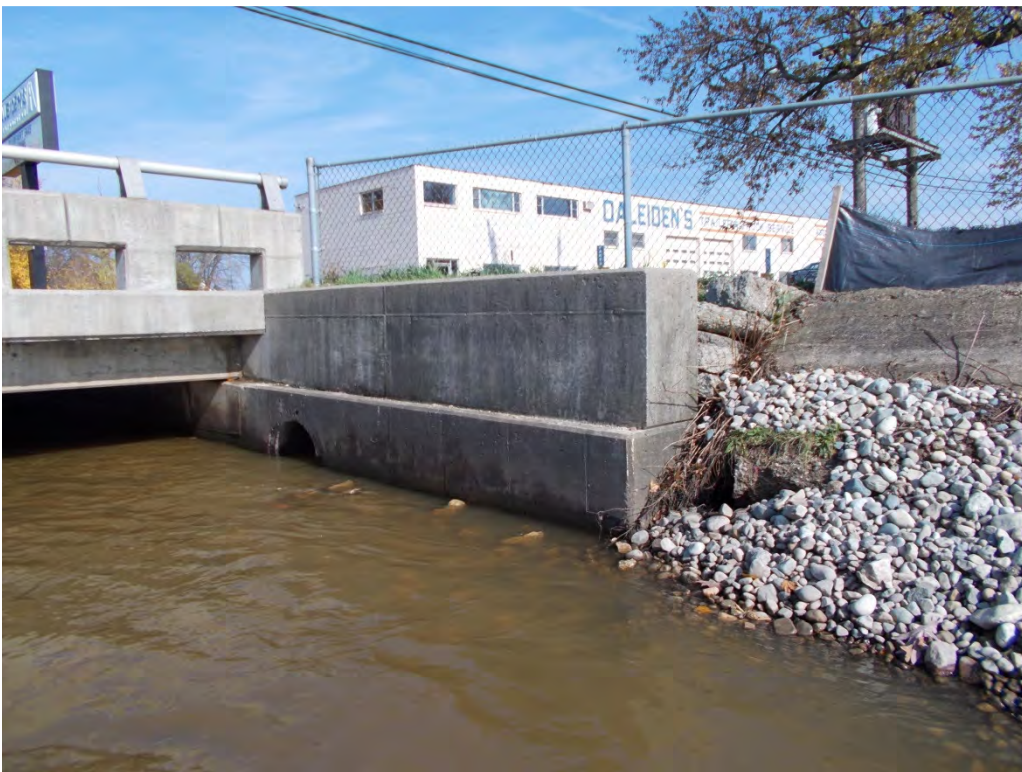
View of southeast wingwall

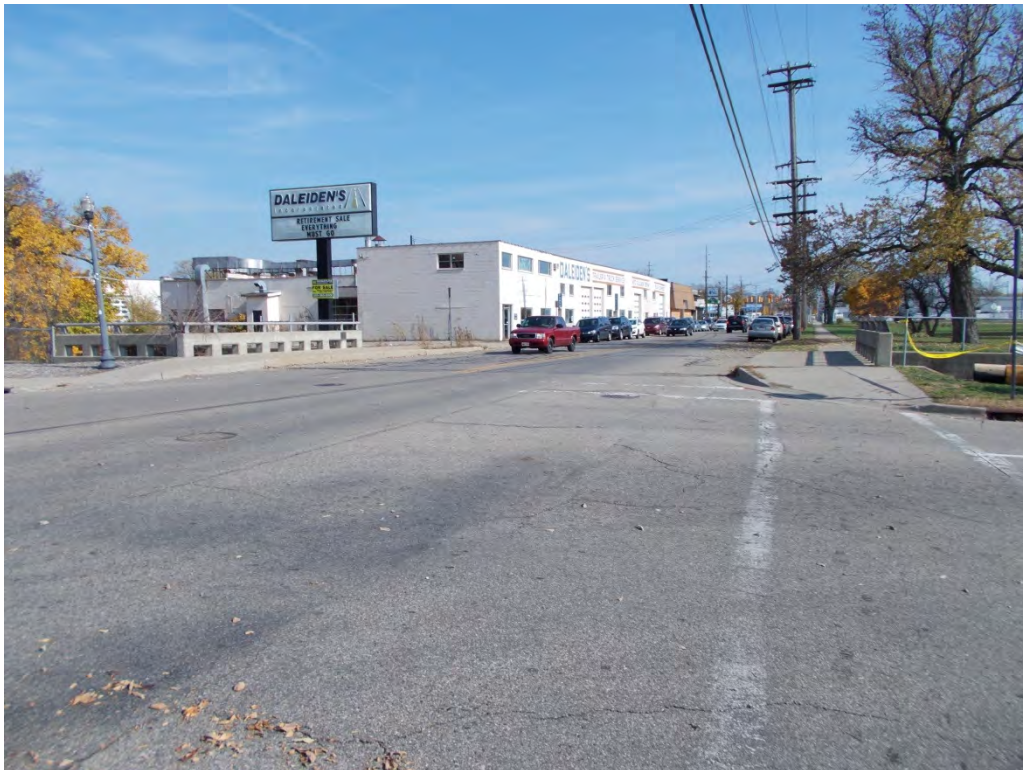
View of structure from the southwest approach area

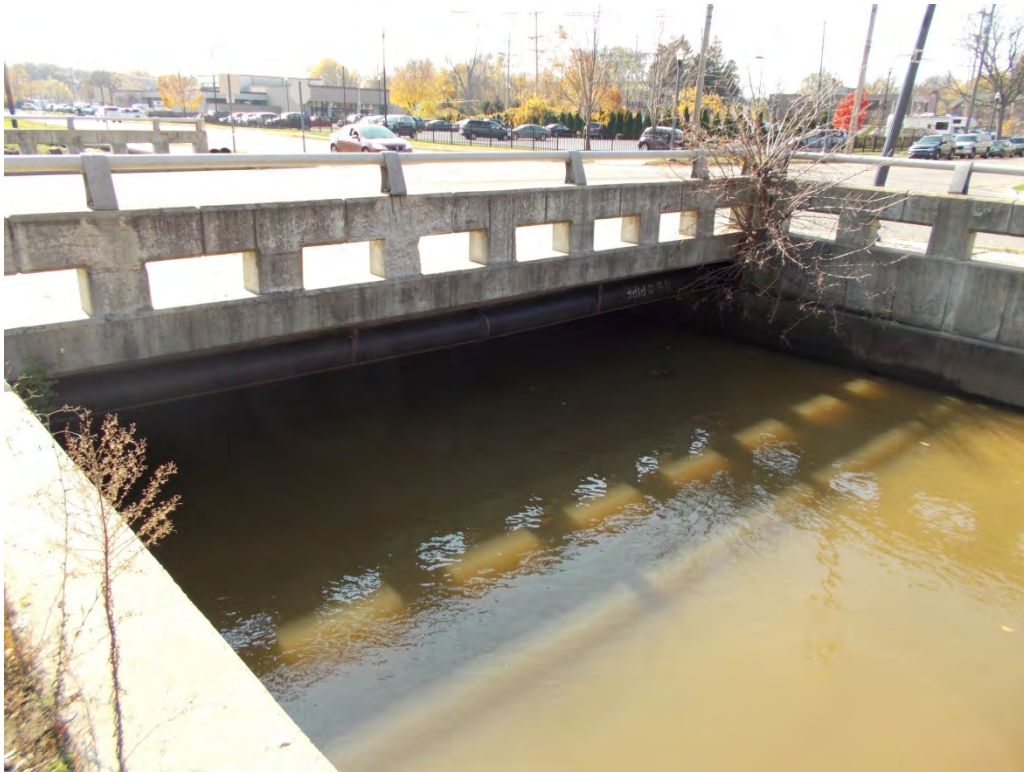
North elevation view of the structure

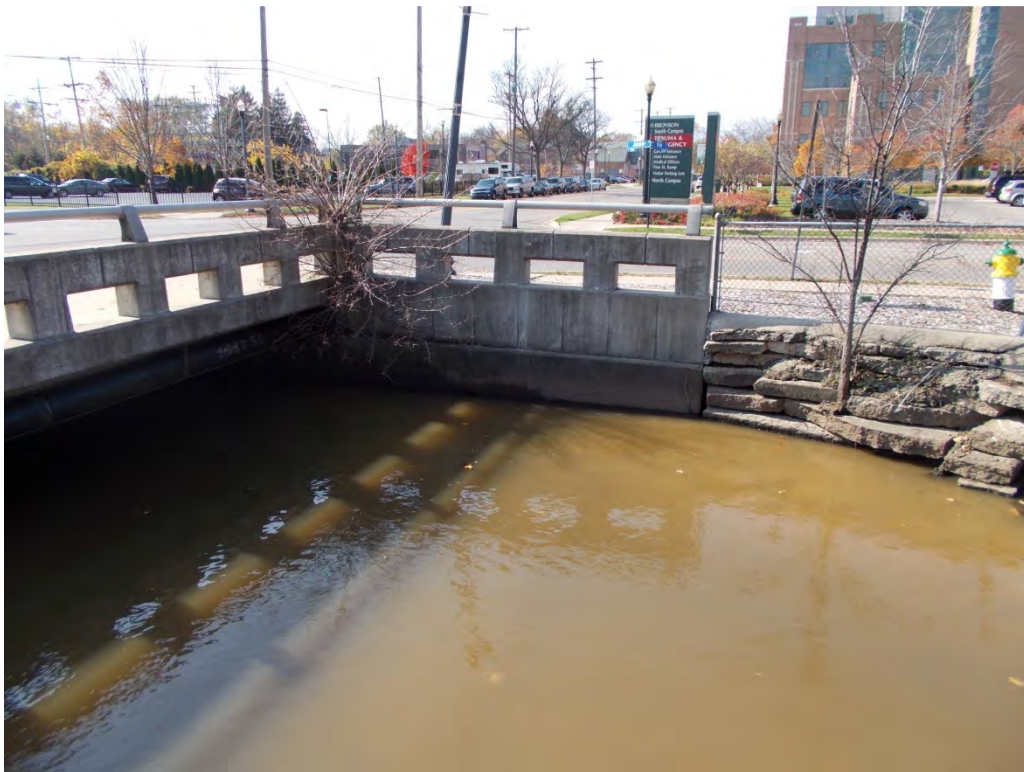
View of the northwest wingwall

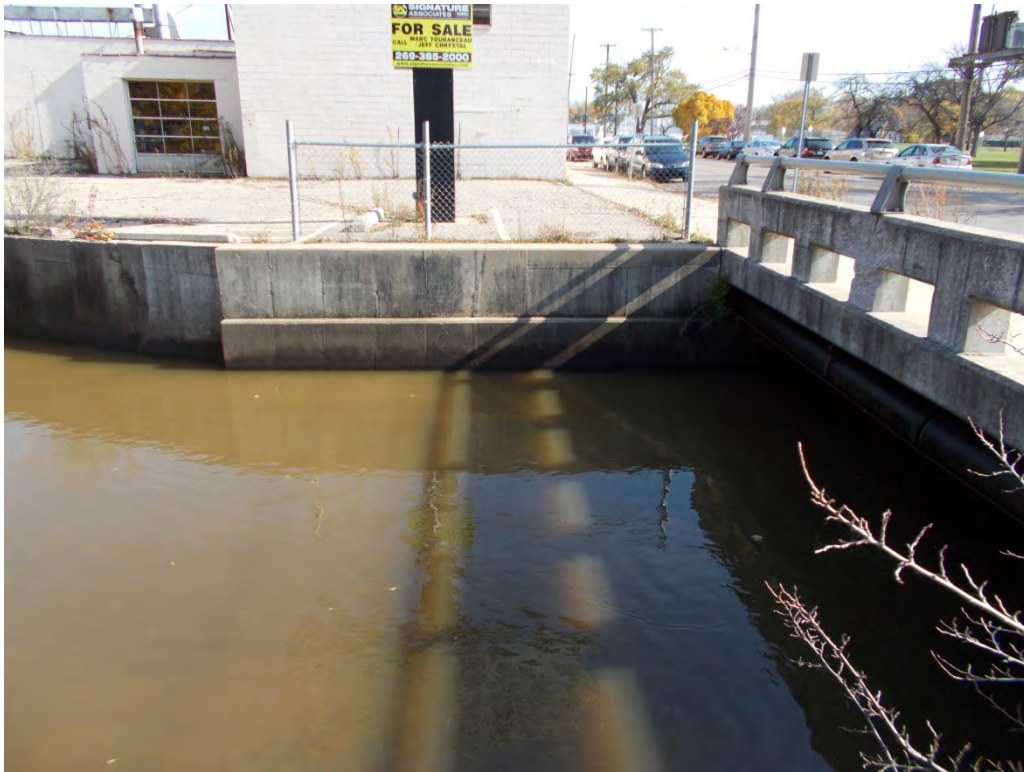
View of the northeast wingwall
